Manhole Inspection Summary

Manhole # S49II_019MH

Inspection ☐ Is Incomplete Rating: **3) Fair**

Location Address: **Luzerne**

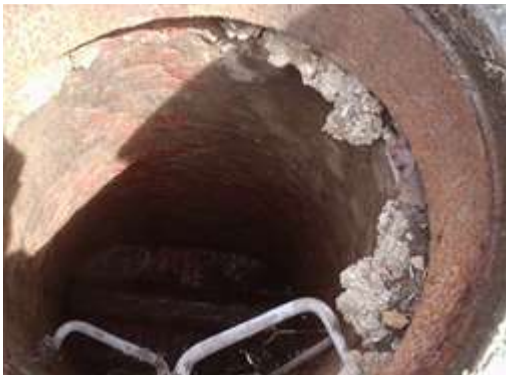
Defect 1

deterioration

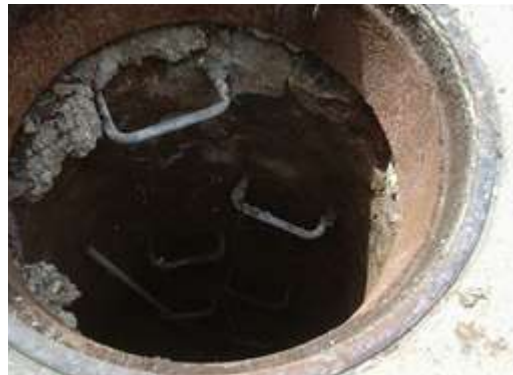
Defect 2

Condition: ☐ Sound ☐ Cracked ☐ Root Intrusion ☒ **Loose Brick** ☐ Deteriorated

Infiltration: ☐ None ☒ **Joint** ☐ Cracks ☒ **Mortar** ☐ Roots ☐ Wall

loose bricks

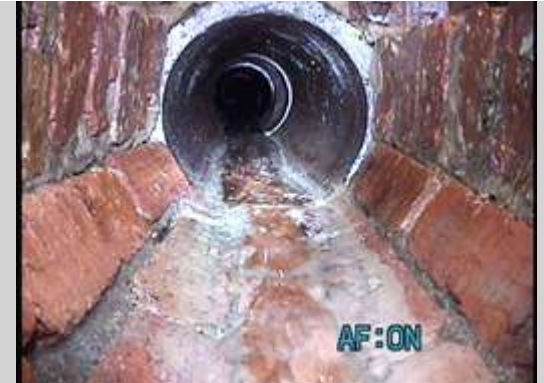
12 O'Clock Outflow

8 in. Circular Gravity Sewer
Pipe Out @ 12 O'Clock

Pipe Height: **8.4** (in.) Rod and Bar (Angled)
Pipe Material: **Clay** ☐ Pipe Lined
Invert Depth: **9.85** (ft.) Flow Characteristics: **Fast**
Deposits: ☒ None ☐ Mud ☐ Sludge ☐ Debris ☐ Grease
Silt Depth: (in.) Deposits Extent:
Infiltration: **None** Pipe Seal Cond: **Sound**

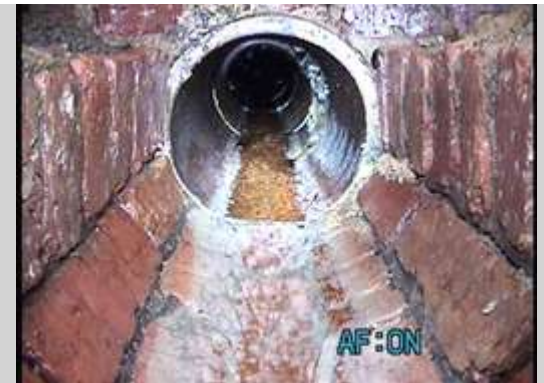
6 O'Clock Inflow

8 in. Circular Gravity Sewer
Pipe In @ 6 O'Clock

Pipe Height: **8.4** (in.) Rod and Bar (Angled)
Pipe Material: **Clay** ☐ Pipe Lined
Invert Depth: **9.65** (ft.) Flow Characteristics: **None**
Deposits: ☒ None ☐ Mud ☐ Sludge ☐ Debris ☐ Grease
Silt Depth: (in.) Deposits Extent:
Infiltration: **None** Pipe Seal Cond: **Sound**
